REPORT DOCUMENTATION PAGE		READ INSTRUCTIONS BEFORE COMPLETING FORM
1. REPORT NUMBER	2. GOVT ACCESSION NO.	3. RECIPIENT'S CATALOG NUMBER
	AD-A091278	
4. TITLE (and Subtitle) Phase I Inspection Report Fresh Air Fund Dam Site I Lower Hudson River Basin, Dutchess County, NY Inventory No. 288		5. TYPE OF REPORT & PERIOD COVERED Phase I Inspection Report National Dam Safety Program

PHASE I INSPECTION REPORT
NATIONAL DAM SAFETY PROGRAM
FRESH AIR FUND DAM I.D. No. NY 288
SITE 1
DEC #212D-1528 LOWER HUDSON RIVER BASIN
DUTCHESS COUNTY, NEW YORK

Name of Dam Fresh Air Fund Dam #1 (Duck Lake)
Fed. I.D. # NT 288 DEC Dam No. 212 D -1528
River Basin Lower Hudson
Location: Town Fishkill County Dutchess
Stream Name Unnamed tributary of Fishkill Creek
Tributary of Hudson River
Latitude (N) 41° 30.5' Longitude (W) 73° 51.5'
Type of Dam Homogeneous Earth
Hazard Category "C" High
Date(s) of Inspection July 9, 1980
Weather Conditions Partly Cloudy; Temp 70's
Reservoir Level at Time of Inspection Approximately 3.0' above crest

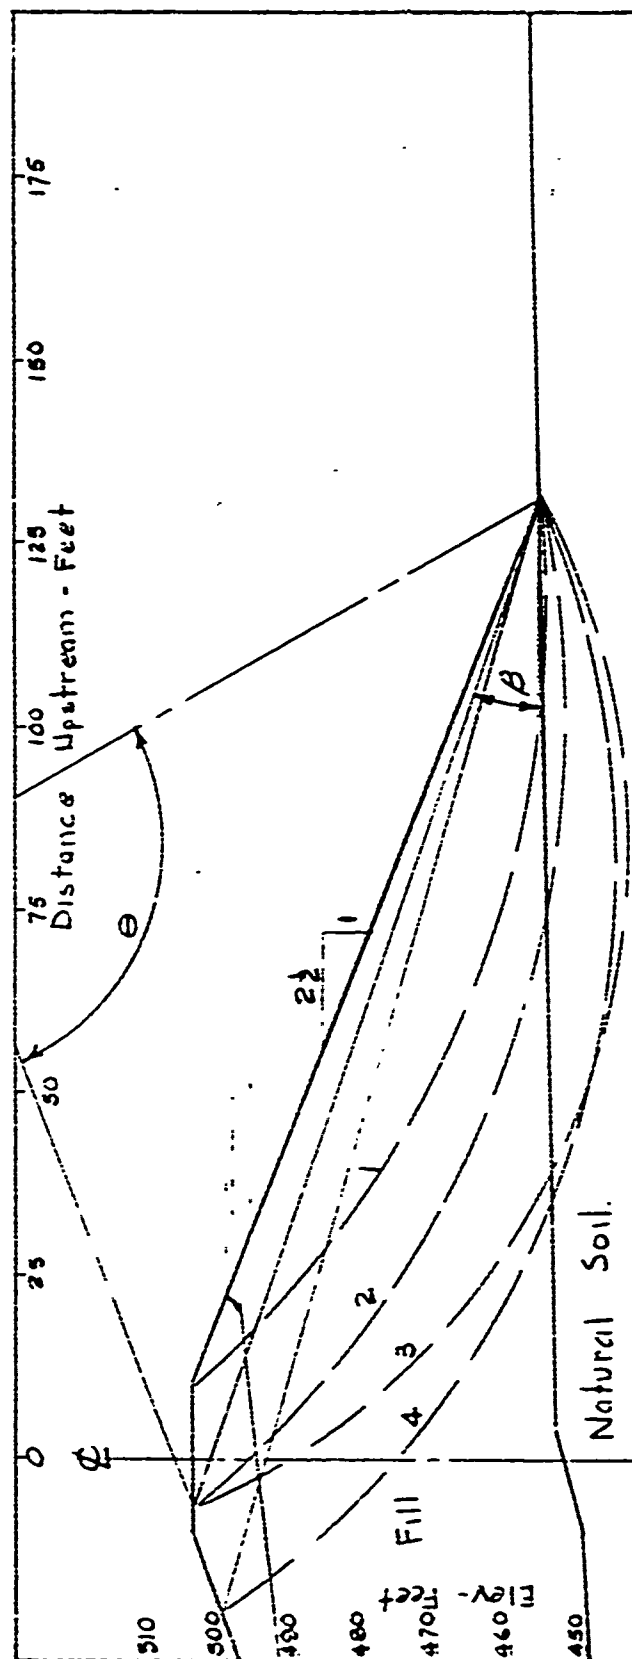
FIG. 23

SOIL CONSERVATION SERVICE
INVESTIGATION OF FOUNDATIONS AND DESIGN
HERALD TRIBUNE DAM
FISHKILL, NEW YORK
VALLEY SECTION - SECTION A-A

Arc	θ	β	Factor of Safety	
			During Construction	Reservoir Full
1	56.4°	21.8°	1.42	1.96
2	64.1°	19.0°	1.29	1.65
3	97.0°	19.0°	1.33	1.63
4	81.5°	16.0°	1.46	1.75
				Sudden Drawdown
				1.028
				0.86
				0.853
				0.925

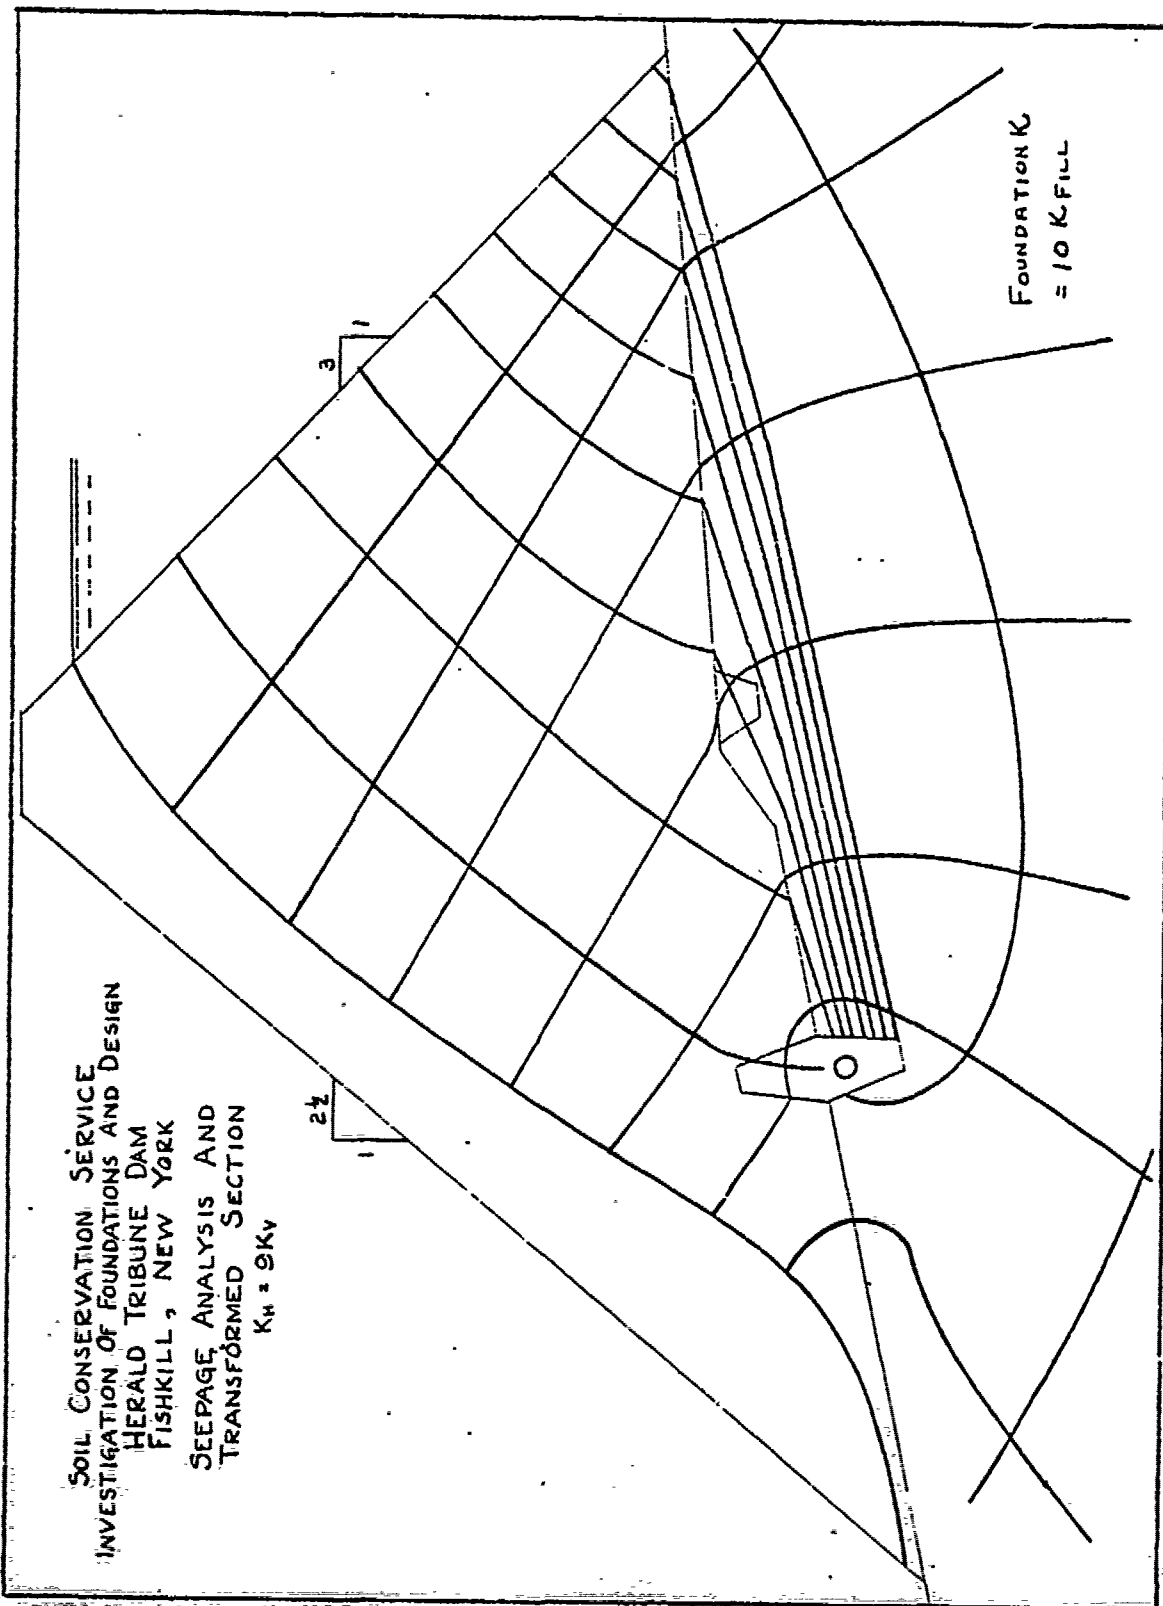
Fig. 28a

A flow net representing the seepage through the embankment under the conditions of a variation of nine times as rapid a flow in a horizontal versus a vertical direction and a foundation permeability four times as great as the embankment permeability is represented in Figure 28(a)(b). These computations indicate that the quantity of seepage through the embankment will vary from 20 to about 180 gallons per minute, depending on the compaction obtained.

SOIL CONSERVATION SERVICE
 INVESTIGATION OF FOUNDATIONS AND DESIGN
 HERALD TRIBUNE DAM
 FISHKILL, NEW YORK
 SEEPAGE ANALYSIS AND
 TRANSFORMED SECTION
 $K_h = 9K_v$
